APPENDIX I

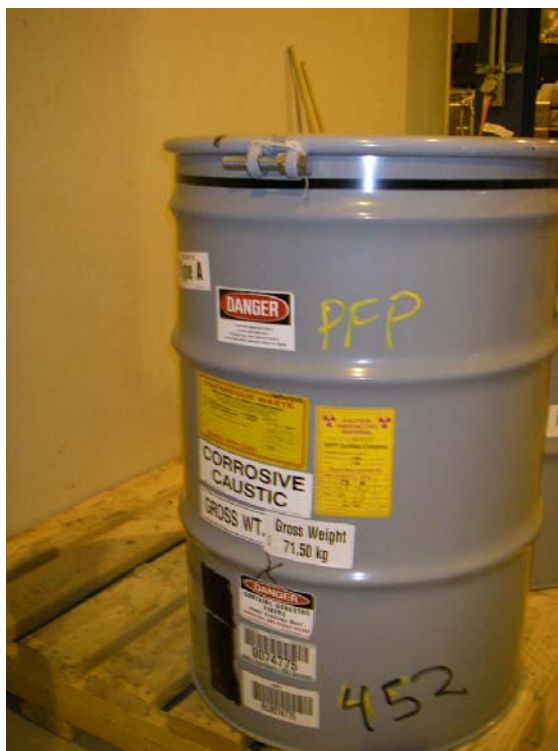
Photo#: IMGP0001 Date/Time: 3/15/2011 10:08:51 AM Photographer: A. Ruhs
Description: Drums of TRU mixed waste inside of WRAP facility, building 2336W

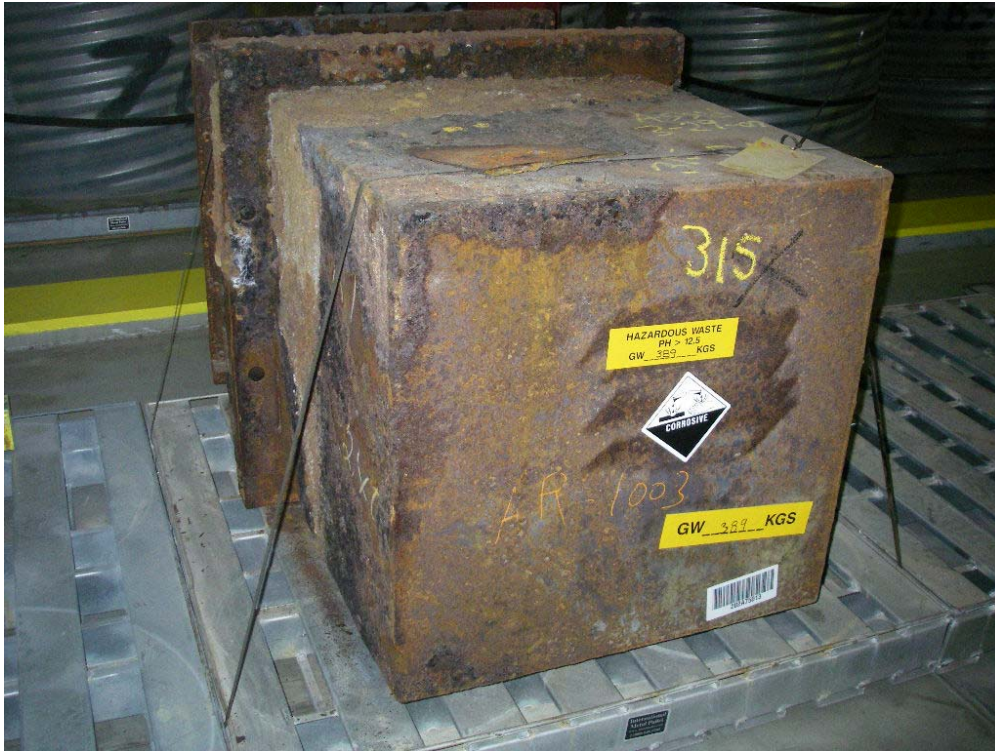
Photo#: IMGP0070 Date/Time: 3/21/2011 11:20:15 AM Photographer: A. Ruhs
Description: This box has been marked non-certifiable (came from 231Z area). Stored in 2403WD building at CWC facility.
